Manhole Inspection Summary

Manhole # S07KK1003MH

Insp Date: **12/23/08 4:19 PM**

Location Address: **4801 CORDELIA AVE**

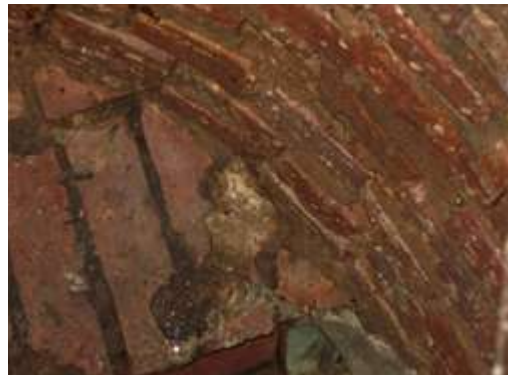
Defect 3

EVIDENCE OF SURCHARGE

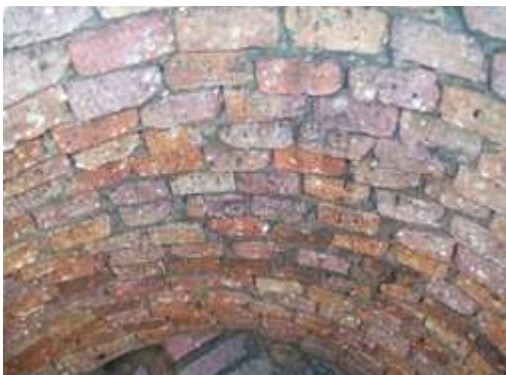
Defect 3

Condition: ☐ Sound ☐ Cracked ☐ Root Intrusion ☐ Loose Brick ☒ **Deteriorated**

CORBEL DETERIORATION

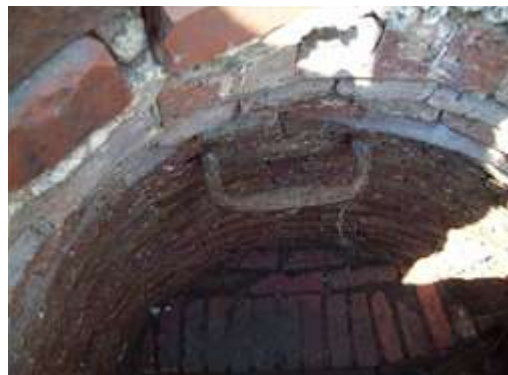
Defect 1

Count: **1** Missing: **0** ☒ **Corroded**

CORRODED STEP

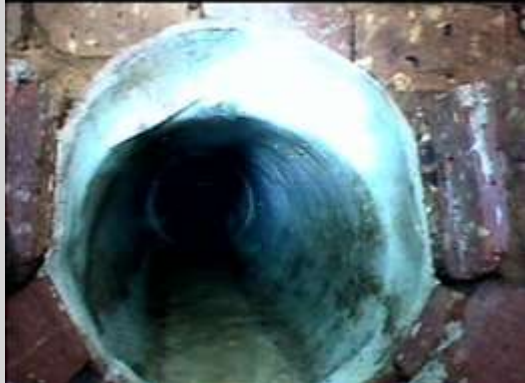
12 O'Clock Outflow

8 in. Circular Gravity Sewer
Pipe Out @ 12 O'Clock

Pipe Material: **PVC** ☐ Pipe Lined

Infiltration: **None** Pipe Seal Cond: **Sound**

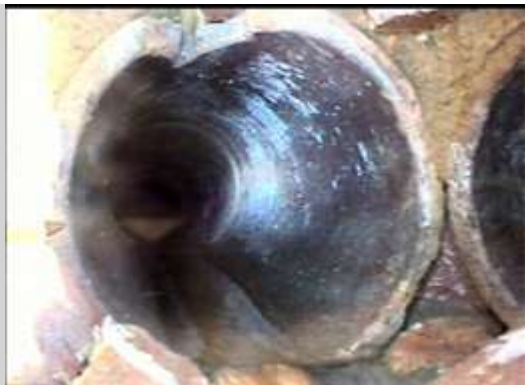
5 O'Clock Inflow

8 in. Circular Gravity Sewer
Pipe In @ 5 O'Clock

Pipe Material: **Clay** ☐ Pipe Lined

Infiltration: **None** Pipe Seal Cond: **Broken**

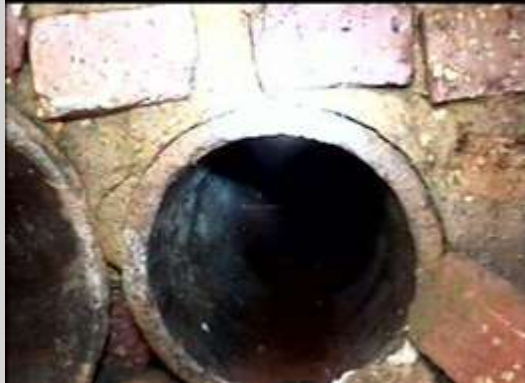
6 O'Clock Inflow

6 in. Circular Gravity Sewer

Pipe In @ 6 O'Clock

Pipe Seal Cond: **Cracked**

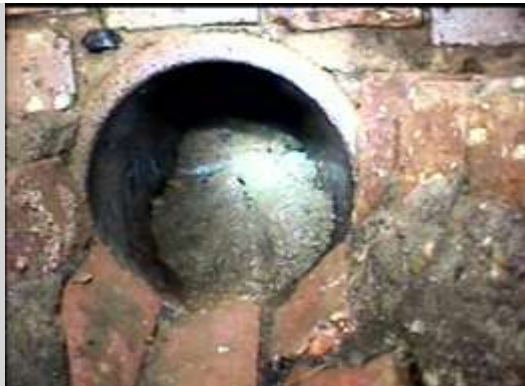
7 O'Clock Inflow

6 in. Circular Gravity Sewer

Pipe In @ 7 O'Clock

Deposits: ☐ None ☐ Mud ☐ Sludge ☒ **Debris** ☐ Grease

Silt Depth: **3** (in.) Deposits Extent: **Medium**
